CASE STUDY

HOME HEIGHT HOUSE, PORTSMOUTH

IKO ULTRA Gold 20

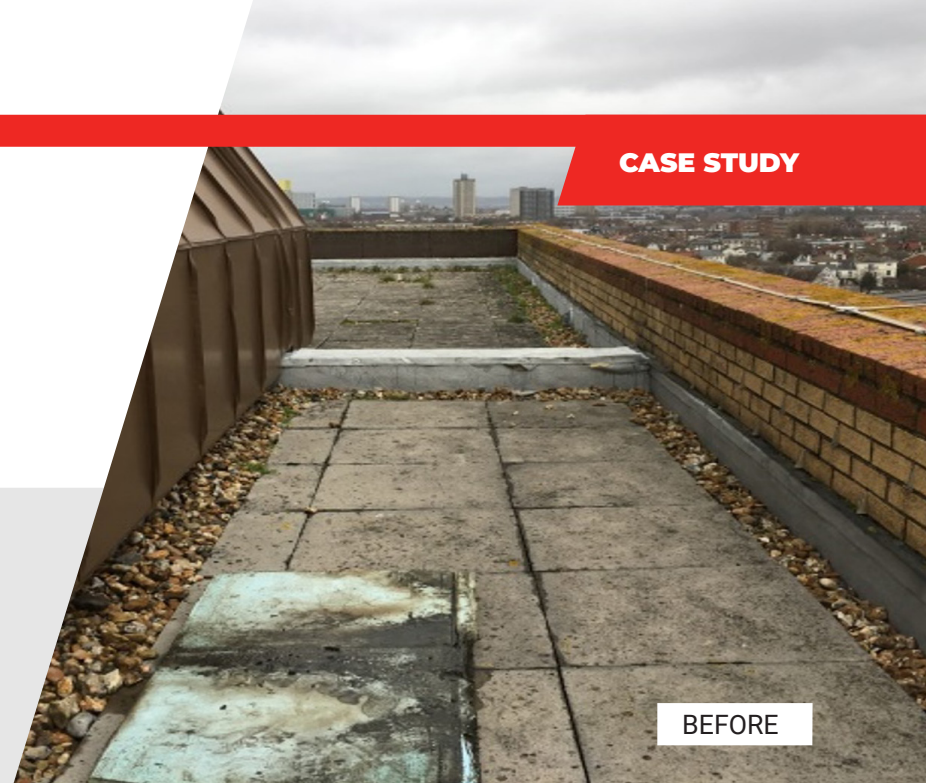
The height of the building and anticipated scaffolding costs were an initial issue. The main roof was covered with paving slabs laid on minimal insulation and the IKO survey found the roof to be saturated. Therefore, the roof had to be fully stripped.

Once the removal of the asphalt had begun it became clear the concrete deck was in a poor, unstable condition and would require stabilising products before the new weatherproofing could be laid.

**BEFORE**

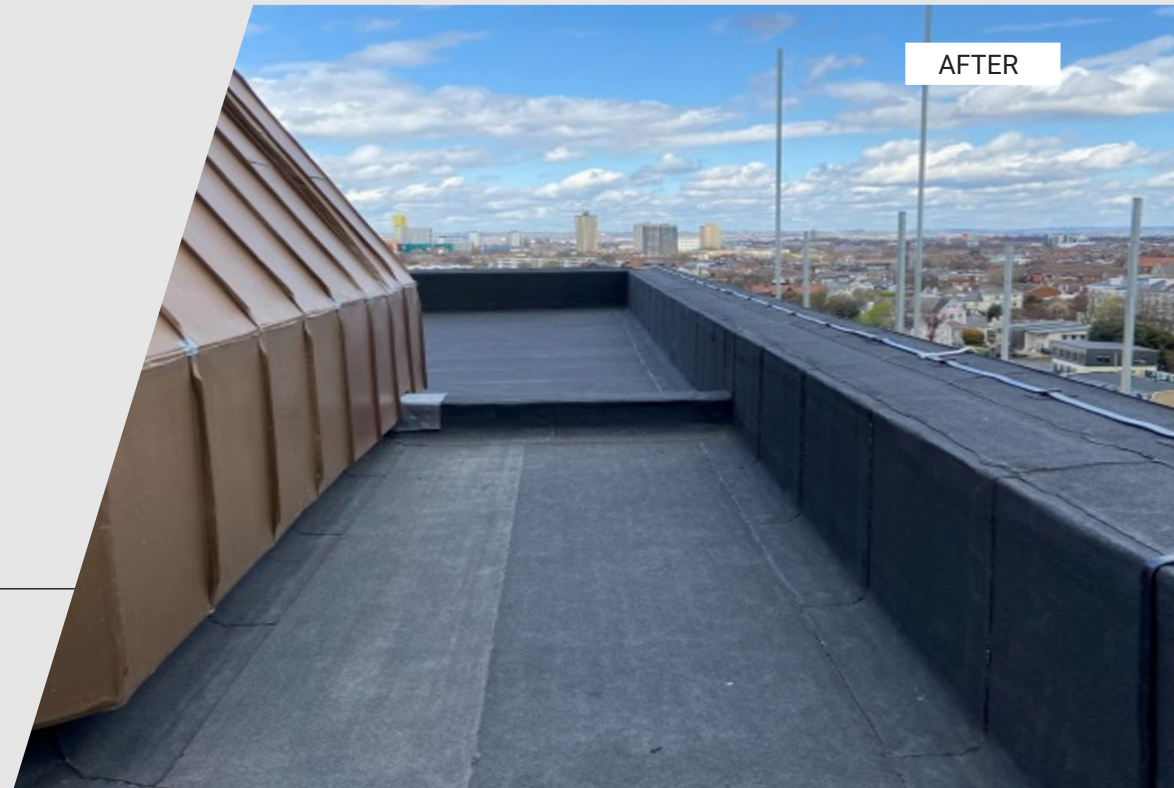
**AFTER**

A tapered insulation scheme had to be designed to ensure water was directed to the internal outlets effectively. In addition to the main roof, three terrace areas were looked at and rectified as there were leak issues from these as well.
