## Polimar CRS (Cladding Refurbishment System)

### Introduction

This is a brief introduction and summary of the new Polimar Cladding Refurbishment System (CRS) designed to coat plastisol coated steel sheets on roofs or in vertical cladding situations. The system is similar to the previous version, although there are different materials included in the system to treat laps and bolt heads on pitched profiled metal roofs.

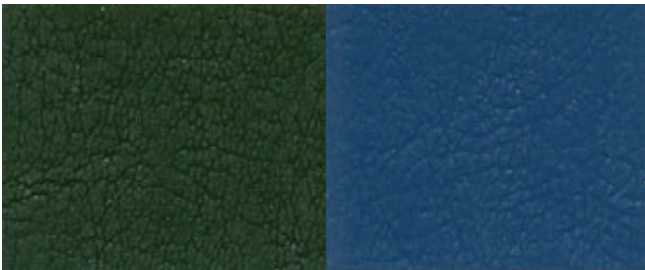
Plastisol finishes will have a 'leatherette' textured finish as in these examples.

Smooth finishes may indicate that the coating is not plastisol (and alternative preparation/primers are required) or previous recoating has taken place.

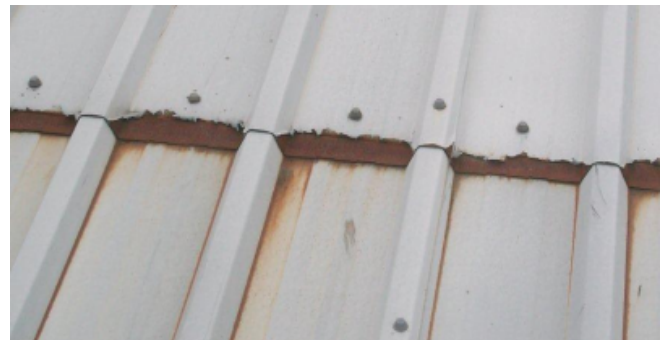
If there is any evidence of reverse side corrosion this must be noted as it is almost impossible to treat as the reverse side of the sheets cannot be accessed. Reverse side corrosion is often indicated by weeping rust stains (as in the image below), corrosion blisters in the sheet above the joint or in extreme cases the sheet will be visible corroded.

Reverse side corrosion is caused by previous repairs to the cut edge joints using systems that are not breathable allowing condensation to occur on the underside of the roof sheets, promoting corrosion from the reverse side.

If reverse side corrosion has occurred then all defective areas of the sheet must be removed and replaced with new to match existing or the whole roof re-sheeted.
