## Fragile Decks - Guidance

### Fragile Decks

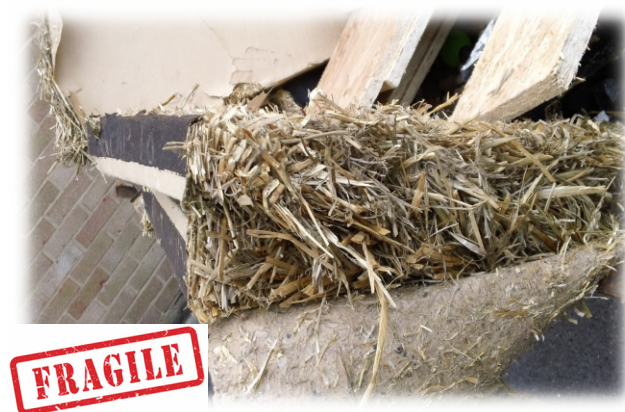
Strammit decks are made from straw that has been compressed under heat and pressure and fused together with their own resins to form a slab typically 35mm to 60mm thick which is covered with recycled paper.

Strammit decks were used as a roof deck material from the mid-1950s. However due to the long term structural stability, especially if contaminated by moisture is now regarded as a fragile material under the guidance in HSG33 from the Health and Safety Executive.

Stramit and chipboard decks must be replaced, without exception.

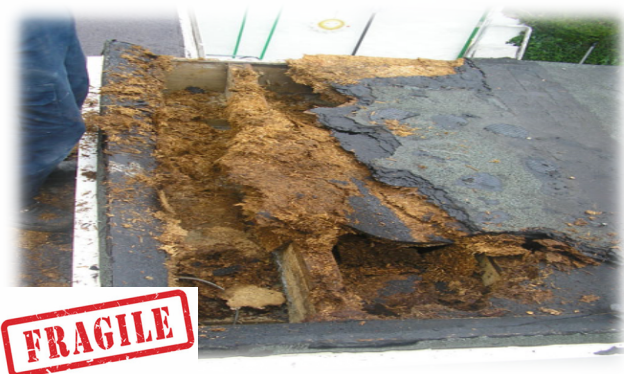
Wood particle board is manufactured from recycled wood chippings that are bound together with resins under heat and pressure to form a rigid board with a smooth finish. The boards are cut to variable sizes.

Wood particle board (chipboard) was used as a roof deck material from the mid-1950s. However due to the long term structural stability, especially if contaminated

by moisture is now regarded as a fragile material under the guidance in HSG33 from the Health and Safety Executive.

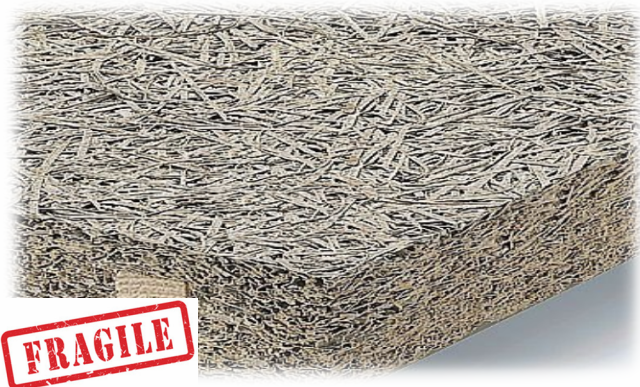
Woodwool is a man-made open textured slab/board material about 50 to 75mm thick comprising shredded timber bound together in a Portland cement paste.

It was used generally during the 1960s until the late 1990s to provide insulation as well as a structural roof decking; it was also used as a permanent shutter to in-situ concrete.

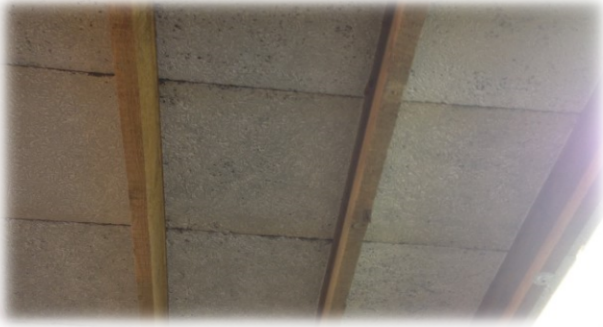
### Woodwool slab (unreinforced)

- Visible damage or staining to the underside, or sagging between joists can indicate wetting or cracking

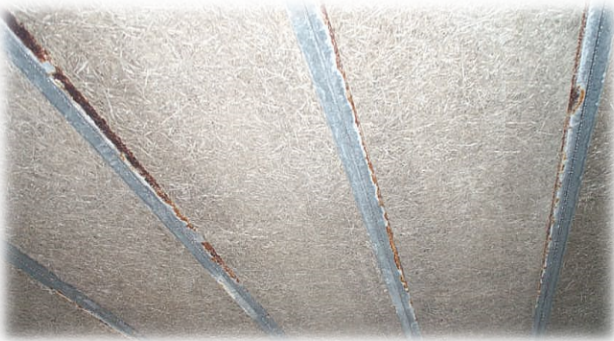
### Woodwool slabs (channel Reinforced)

- As for woodwool slab, plus corrosion of channels, or displacement of slabs from the channels.

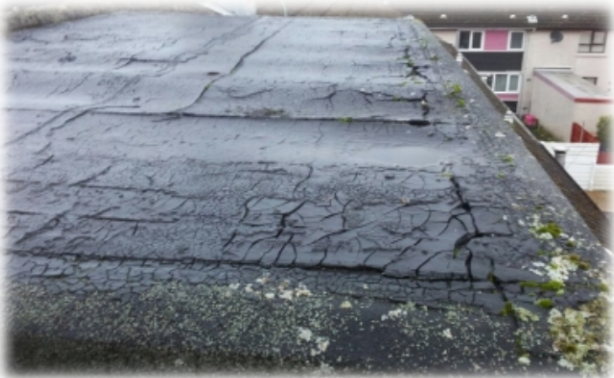
Using pertinent safety measures, an external inspection should follow, which may reveal deflections due to collapse between joists, or other deck damage.

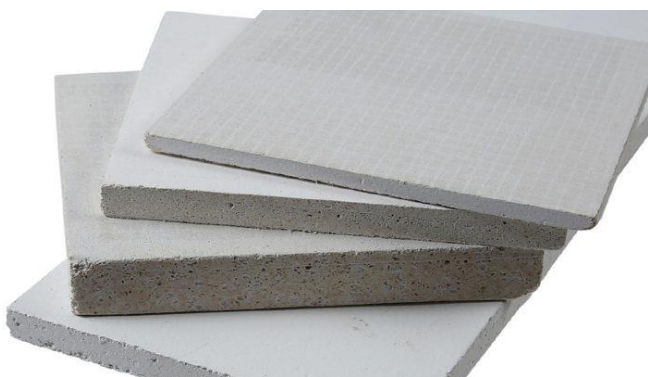
The use of magnesium Oxide (MgO) building boards or similar have been recently proposed for use as sheathing or backing board to rendered system, and in some cases as a structural deck or substrate for flat roofing application in an attempt to comply with the changes within the Building Regulations. This is strictly prohibited and must not be undertaken.
